## *In vitro* study of erosion caused by EDTA on root canal dentin

### *Estudio in vitro del grado de erosión que provoca el EDTA sobre la dentina del conducto radicular*

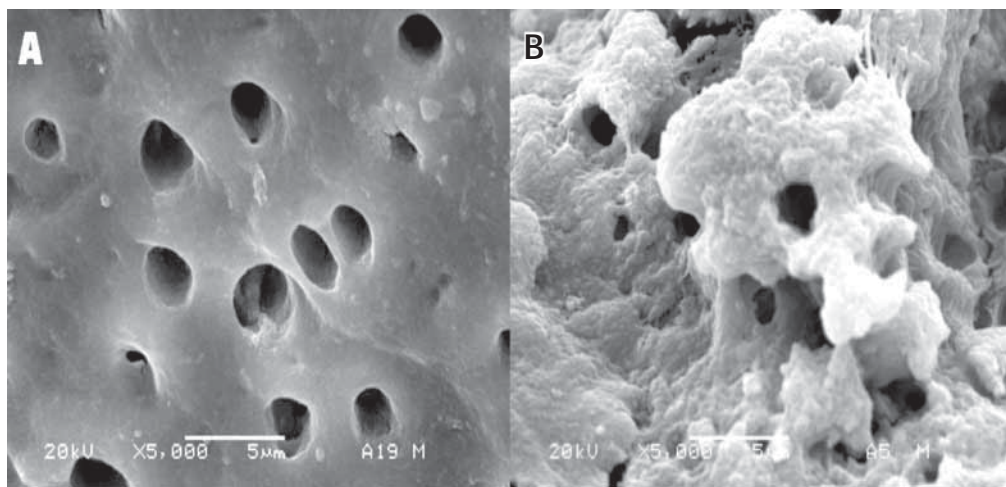
**Figure 1.** Microscopic photographs of middle third show: (A) Normal looking dentin in tubules, surface apparently free of erosion. (B) The canal wall has sustained alterations; severe erosion and severe dentin destruction are observed (5,000X).

When using 17% EDTA on root dentin of the middle third, results showed that, of the total 40 samples, 10 (25%) did not show erosion, 10 samples (25%) showed moderate erosion, and 20 samples (50%) showed severe erosion. (Table I). A 1:3 relationship is observed in the degree of erosion on the root dentin of the middle third. This is to say, that, for each sample that does not show any type of erosion, there are three samples showing erosion. Microphotographs in figure 1 show normal looking dentine tubules, and, the dentin surface with severe erosion both on the middle third.

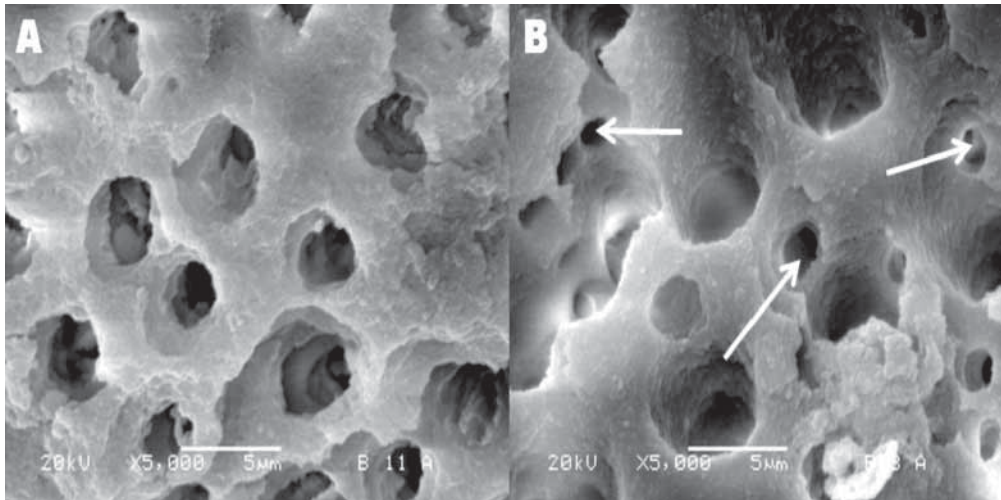
**Figure 2.** Microscopic Photographs of apical third: **(A)** Moderately eroded dentin, there is damage on the dentin surrounding the tubule, as well as enlargement and irregularities at the tubule entrance. **(B)** Severely eroded dentin. There is destruction surrounding and inside the tubules. Communication among dentinal tubules allows to observe dentinal canaliculi (arrows) (5,000X).

When using 17% EDTA on the root dentin of the apical third, it was observed that, out of the 40 samples treated with 17% EDTA, 17 (42.5%) did not show any kind of erosion; 11 (27.5%) showed moderate erosion and 12 (30%) presented severe erosion (Table II) A 1:1.3 relation is shown in the degree of erosion on the root dentin of the apical third. The microphotograph shows dentin with moderate erosion and severe erosion in the apical third (Figure 2).
